September 26, 2014

PRESS RELEASE

North Coasts Mykonos Island - Wreck removal and antipollution activities of MPP Yusuf Cepnioglu completed

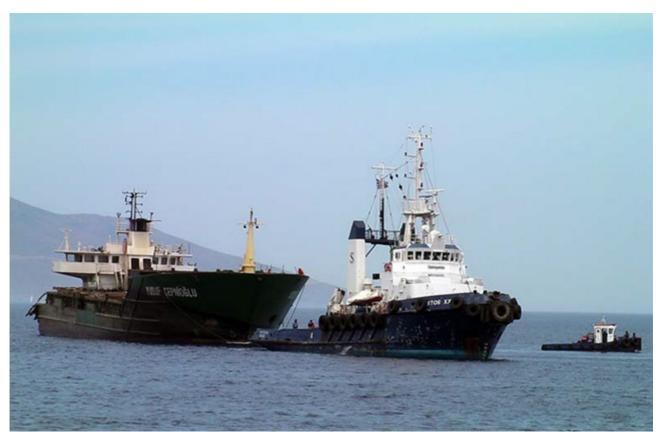
Christos XXII towing forward section of YUSUF CEPNIOGLU

The refloating operation of the rest part of the vessel, which contained the fwd parts with cargo holds 1 and 2, which was reflecting to the 4/5 of the total length of the wrecked vessel Yusuf Cepnioglu has been also successfully completed since 29 th May 2014, whereas salvors attempts managed to stabilize her refloatting and stability criteria, in order to become safely afloat for towing her away from the wreck site.

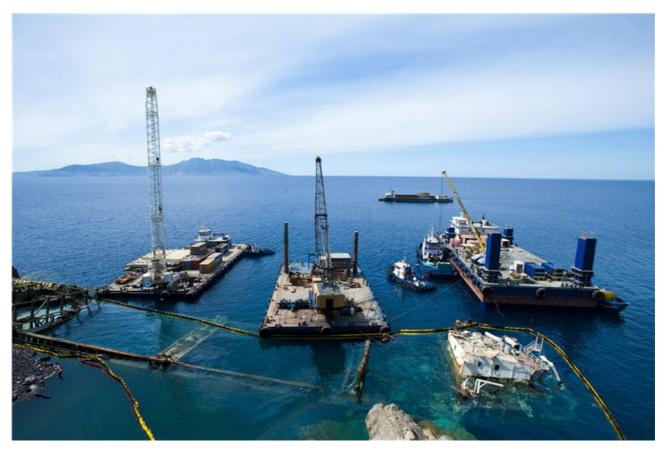
Salvage Spread on site

Furthermore, for the implementation of the afore mentioned operations a number of versatile equipment has been occupied and remain on site up to date, fully manned with project manager, salvage superintendents, consultants, marine engineers, naval architects, seafarers and various expertise employees.

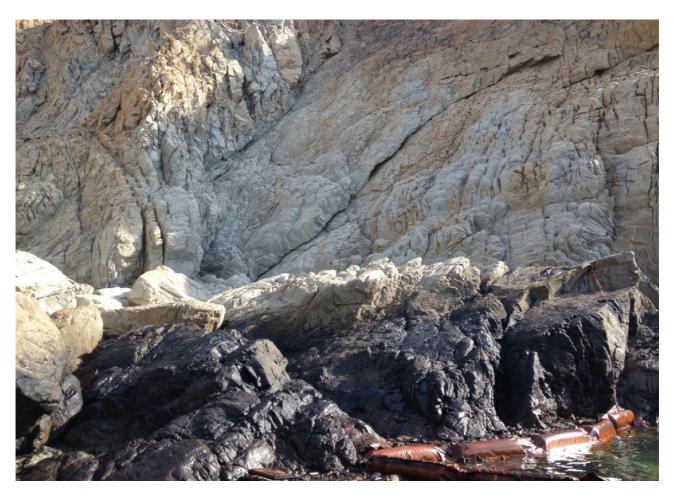
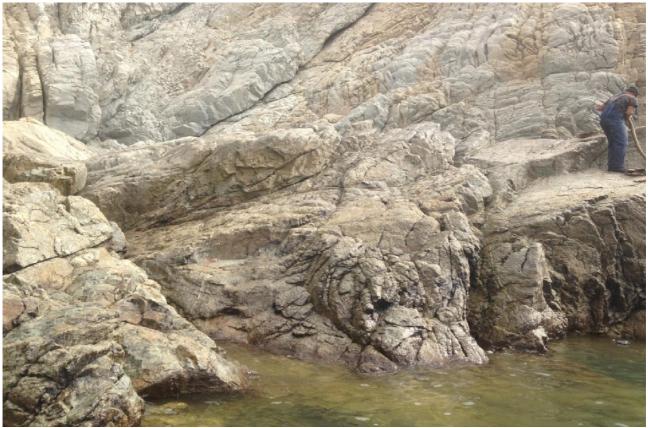
Sample of Before-After Pics arisen after the cleaning of oil-soiled rocks of adjacent coastline of the Yusuf Cepnioglu.

The wreck removal operations of the Turkish flagged container vessel Yusuf Cepnioglu has been awarded to the Christos XXII Spanopoulos Tugs Maritime Company since the 5 th of May 2014. The said contract contained a major project for the greek waters containing numerous challenging activities like (except of the wreck removal) the recovery of her remaining containers within Cargo Hold # 1, collection of debris, antipollution activities on the adjacent beach (including cleaning of coastline), seabed debris recovery activities, disposal of waste, cargo and the vessel's hull and several antipollution activities in a vicinity of 1500 meters from the wreck site and in every direction.

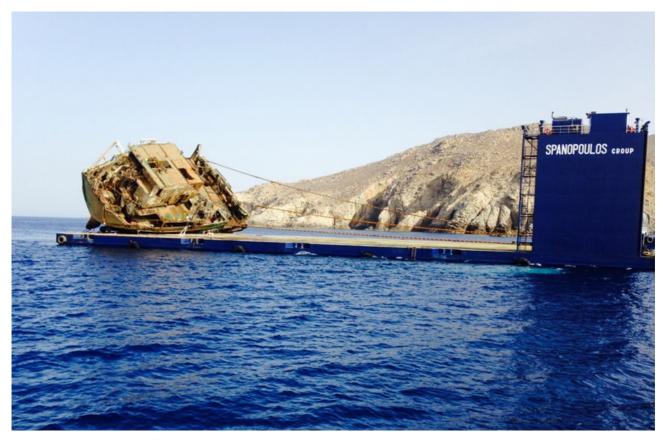
The aft section of YUSUF CEPNIOGLU on-board semi-submersible barge Atlantis I

The salvage company Christos XXII Spanopoulos Tugs Maritime Company, proud member of Spanopoulos Group and ISU respectively on Monday 22nd September 2014 early morning hours has successfully completed the wreck removal of Yusuf Cepnioglu aft section (engine room block including accommodation), which has run aground on the 8 th March 2014 at the rocky north coasts of Mykonos Island.

The final step of the wreck removal operation has been successfully accomplished by using the semi-submersible barge Atlantis I, which is fitted with ballast system for the sinking and floating operation(s) and tailor made pulling systems for this particular operation, in order to be able to drag the aft section underwater and on a depth of 22.5 meters and then by de-ballasting the Atlantis I, in order to bring the recovered aft section of Yusuf Cepnioglu, above water.
